**HIGHWAYS AGENCY AREA 6
MANAGING AGENT CONTRACTOR CONTRACT**

A47 NORTH BURLINGHAM DITCH

**PRELIMINARY SOURCES STUDY/ REMEDIAL OPTIONS STUDY
REPORT**

March 2015

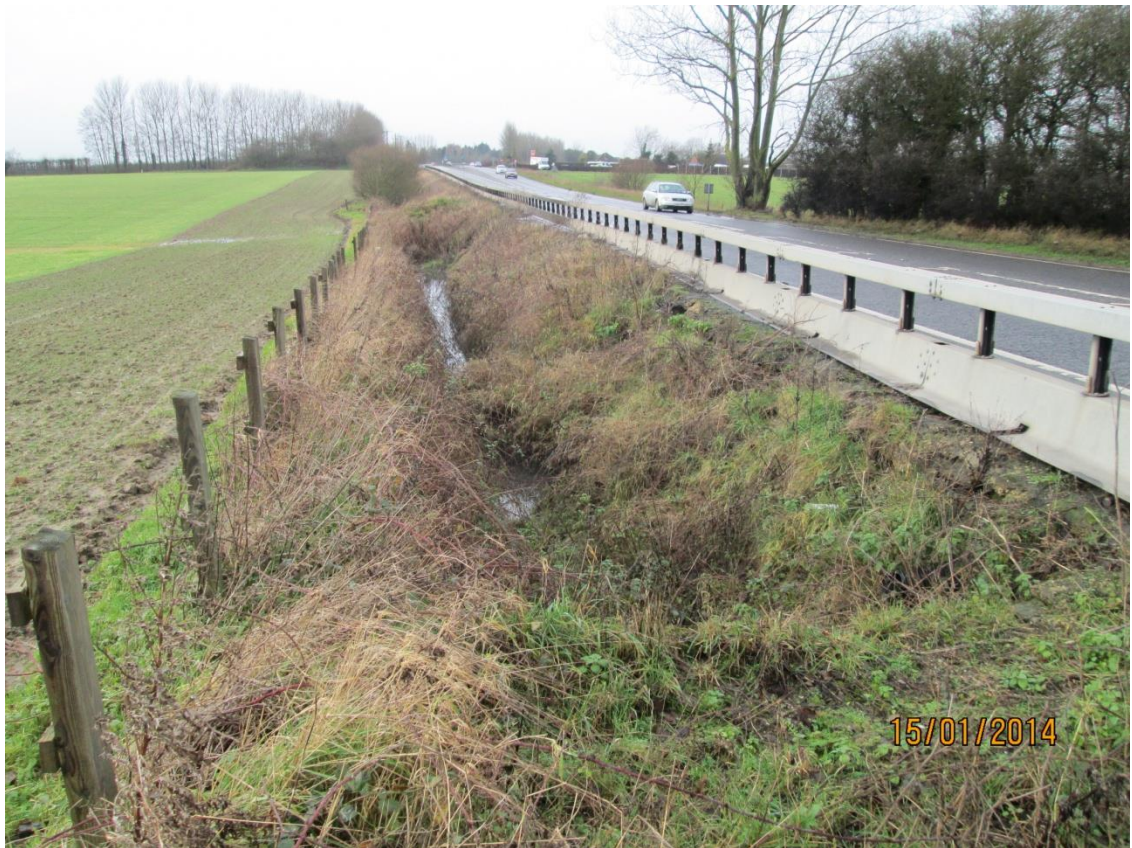
- The drainage ditch at the site appeared to act as a soakaway, was partially filled with water and in need of maintenance. (photos 1,5, 6)
- 2 areas of the side of the ditch adjacent to the road side had failed, slumping into the ditch base. Photos 5 and 6

Photo 1 Looking along ditch with failure material in foreground and level with car

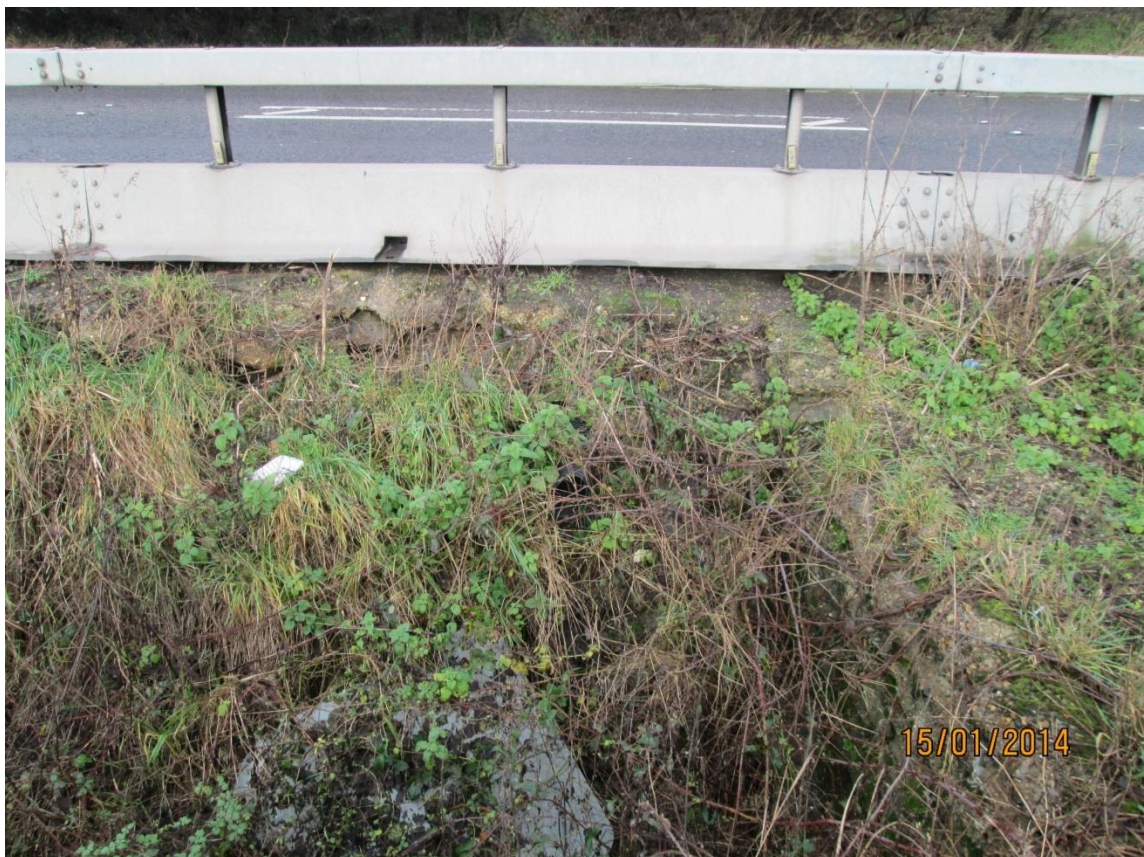
- A previous repair or outfall detail had been carried out around the outfall pipe (Photo 8) . This was not visible on site although part of the bagwork appeared to be in place adjacent to the outfall pipe Photo 2

Photo 2 Area of failed material with black pipe visible through brambles – possible bag work repair on right

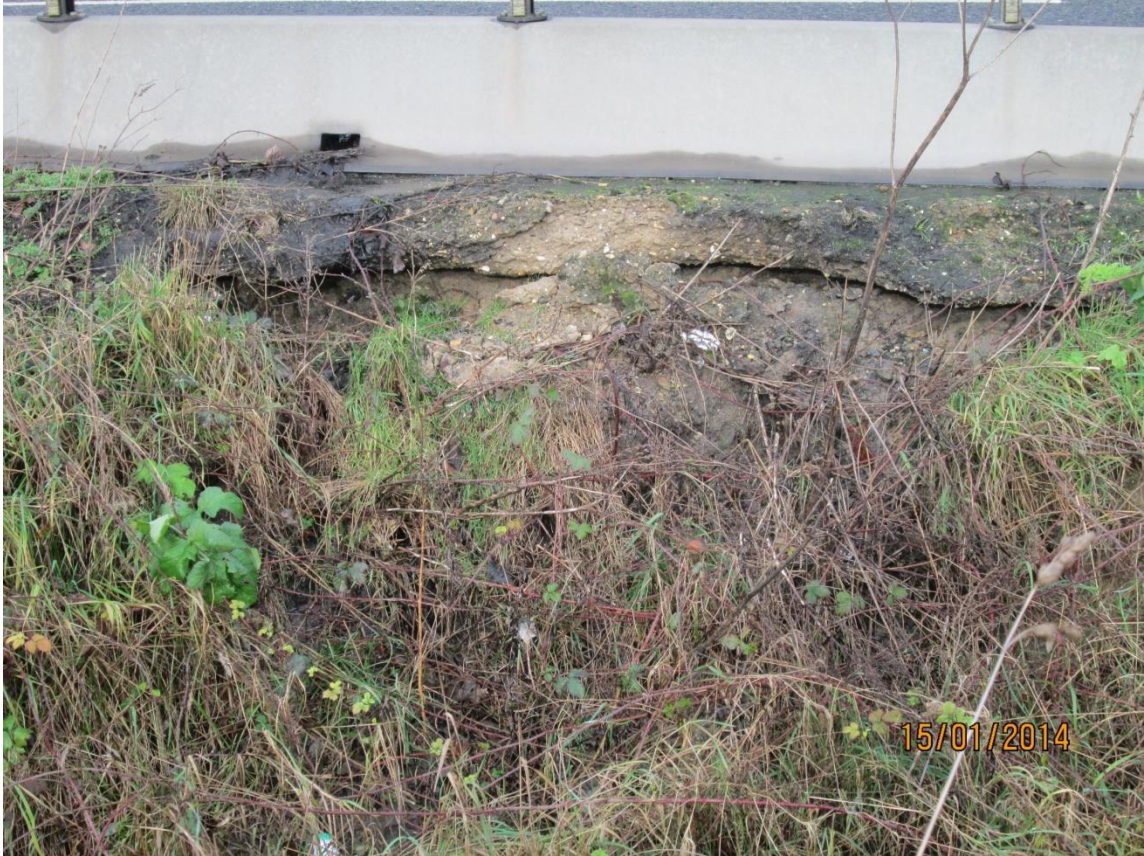
- The edge of the road pavement where the material had failed was shown to have extensive layers of concrete below the road pavement. The nature and composition of the road pavement and underlying sub-base layers need to be determined. (Photo 3)

Photo 3 Area of failed material exposing depth of concrete under road pavement, possibly reflecting haunch repairs

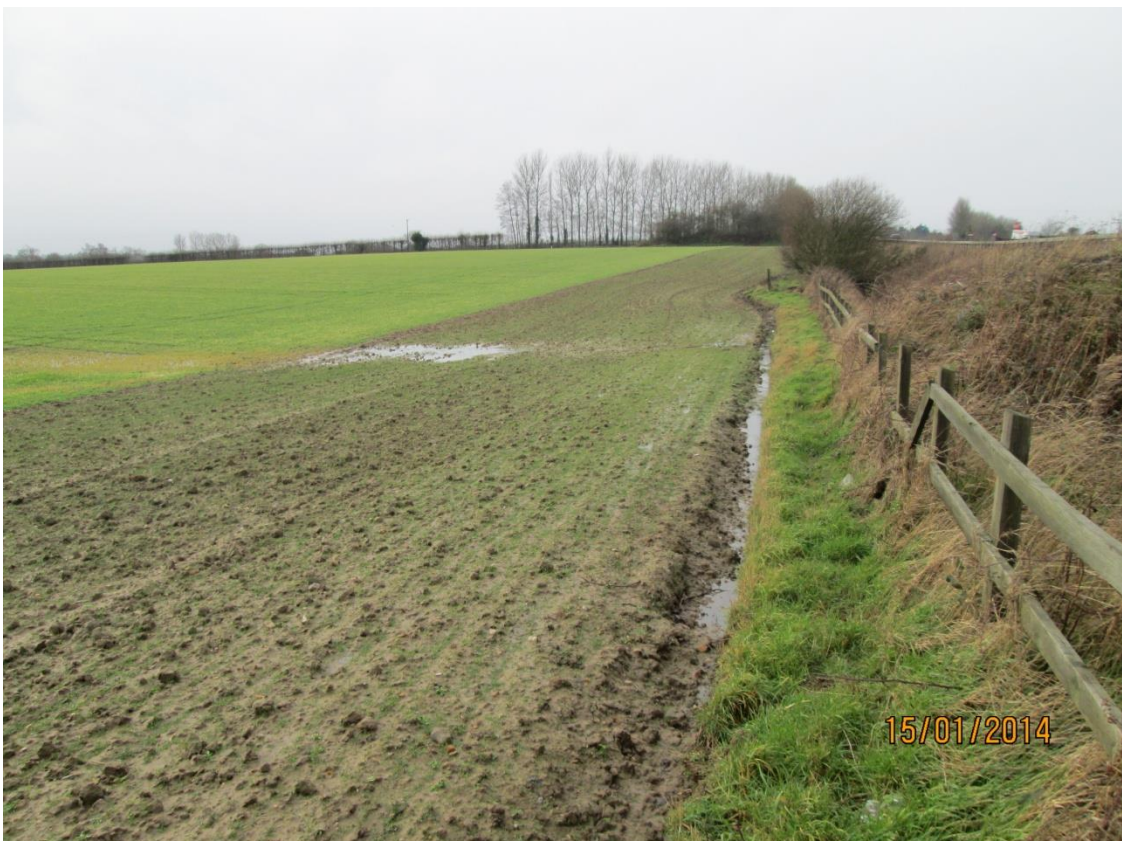
Photo 4 Field showing area of standing water

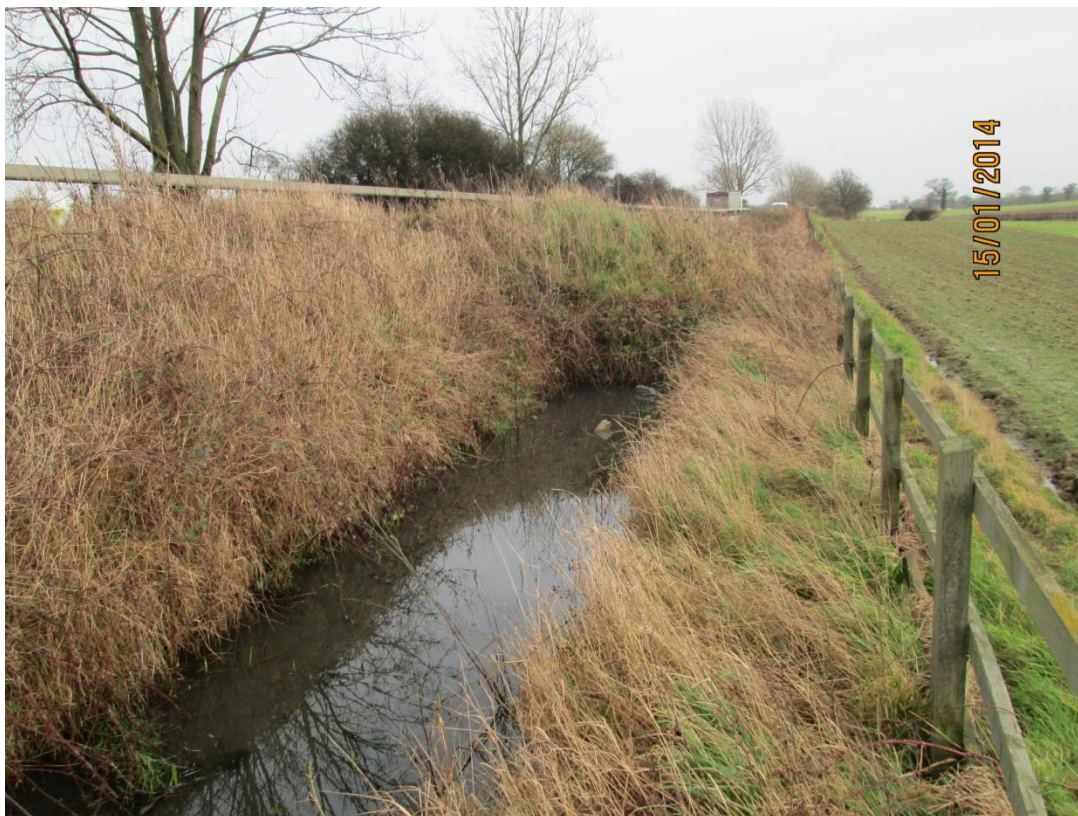
The probable cause of this defect is a combination of relatively soft ground conditions, steep ditch sides and water pipes outfalling to the ditch.

Photo 5 Ditch showing failed material in ditch base

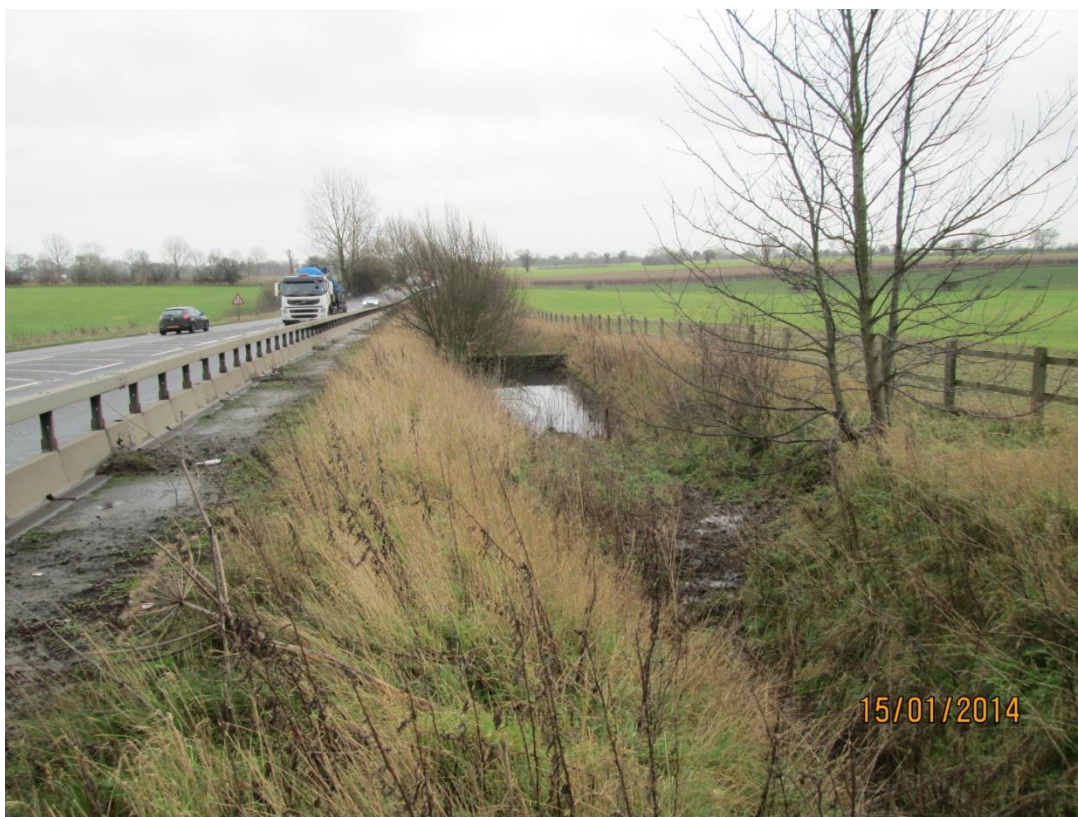
Photo 6 Ditch showing failed material in ditch base

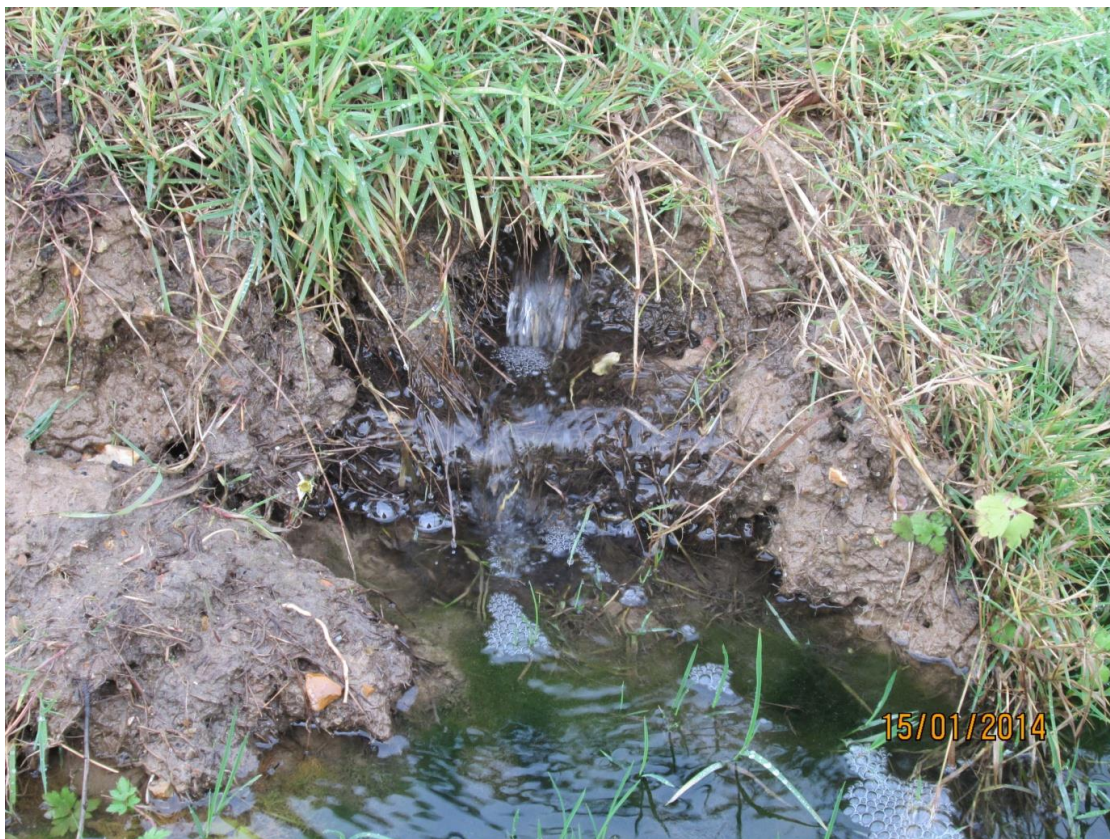
- An additional pipe with water flowing was found at the slope failure location (Photo 7)

Photo 7 water flowing from possible pipe outfall

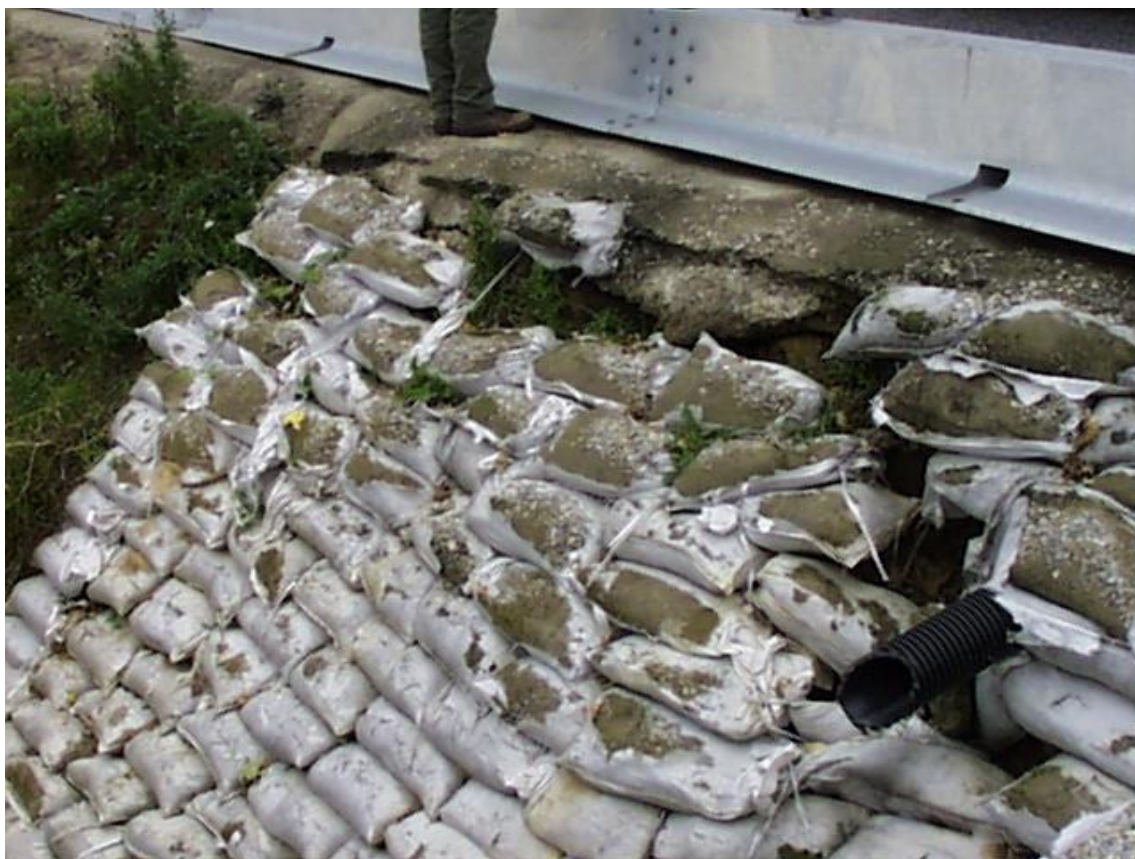
Although not a geotechnical risk it is highlighted here that the varioguard appears to have been in place for 10 years, and is thus well over the HA recommended 4 years limit. However until the ditch defect is remediated it will be required to remain in place.

Photo 7 : 2004 inspection showing bag work with outfall pipe and varioguard in place
