Guidance Note on the Field Identification and Classification of Geotechnical Observations

Document Title	Guidance Note on the Field Identification and Classification of Geotechnical Observations
Author	Tony Daly
Owner	David Patterson
Distribution	HE and suppliers
Document Status	V2.0

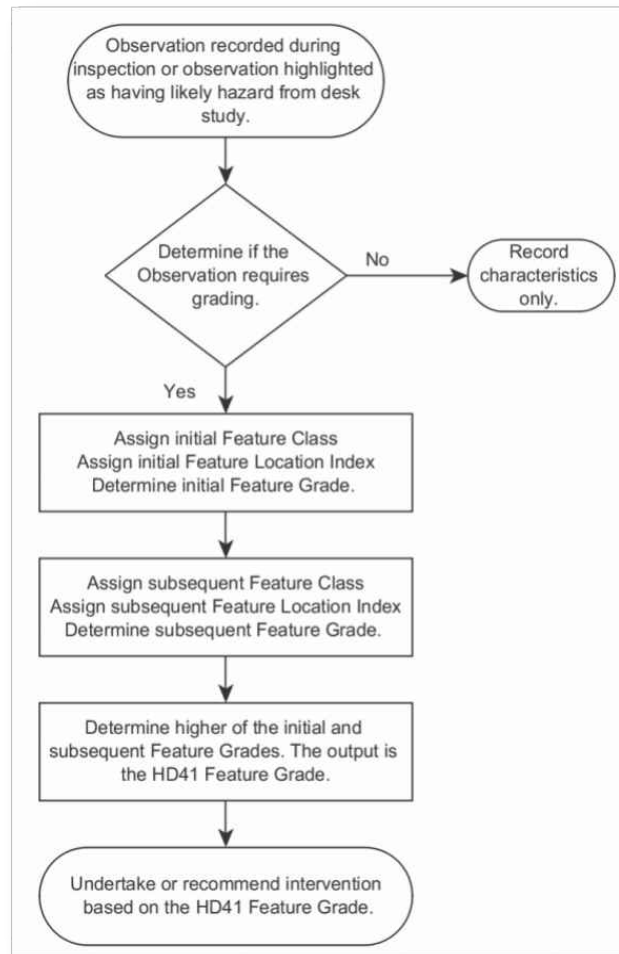
Figure 2 Feature Grading Process to determine the requirement for immediate geotechnical interventions (Figure 2 of HD41/15)

The assessment process is shown in Figure 2 of HD41/15. It is also shown overleaf:

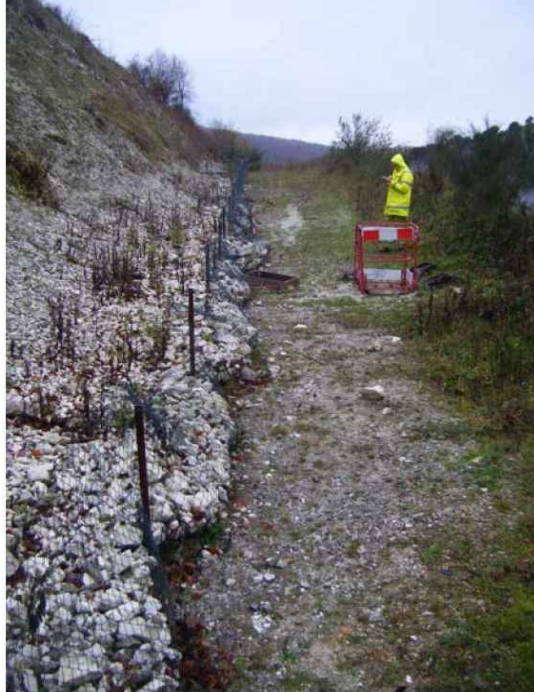
Figure 5 Ravelled material from a rock slope

The volume of failed material should be recorded as a total volume for the particular observation being measured. It is recognised that this measurement may be challenging to record with any great degree of accuracy in certain cases (see for example Figure 5). Where possible, measurements should be taken using a tape to record each dimension, and a volume calculated.

Where the material is small size (such as in Figure 5), reference to recognisable volumes may prove useful, for example:

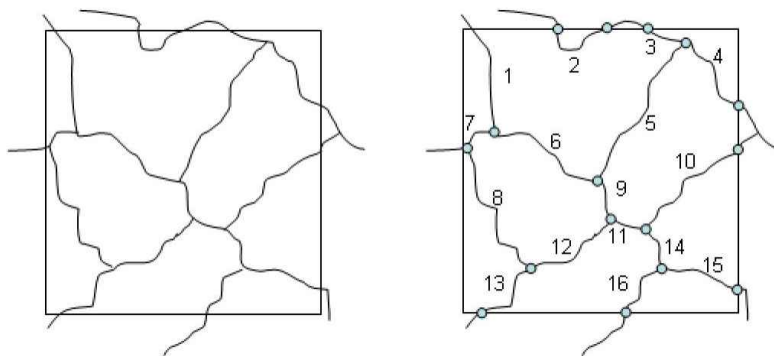
Figure 7 Suggested method for desiccation crack measurement

Measurement of desiccation cracking density is likely to be challenging in some cases, and an agreed and reproducible method should be employed for repeat visits to a defect. A suggested method would be to define each crack to be counted (within a defined area) as a single section of crack between 'node' points (which may be at the intersection between crack sections, or crack sections and the edge of the measured area). See Figure 7 for an example.

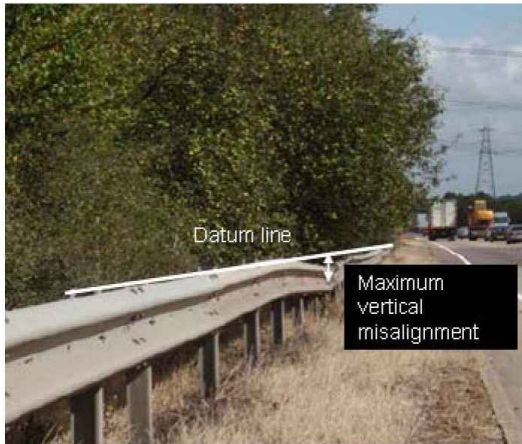
Figure 8 Measurement of vertical misalignment

The measurements, taken in the horizontal and vertical planes, should be taken at their maximum point, or at the point of maximum significance. To ensure accurate and reliable measurement, consideration should be given to marking out the measurement point if practical. One method of measurement that could be utilised is to stretch a taught line across the measured feature, from 'stable points, to create a datum line and measure the

maximum misalignment to the feature from that line (see Figure 8).

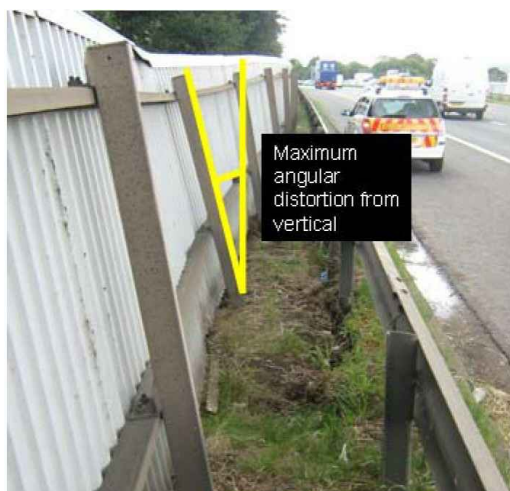
Figure 9 Measurement of angular distortion of a fence post

This measurable is intended to record the maximum angular distortion of a feature from its intended orientation. In most cases, this will be a deviation from the vertical, but a horizontal element to the total misalignment can also be recorded (see Figure 9).

Many of the sighting clinometers used to determine slope angles in Geotechnical Asset inspections also have a dial that can be used to obtain accurate measurements. Alternatively, a compass with clinometer needle can be used.

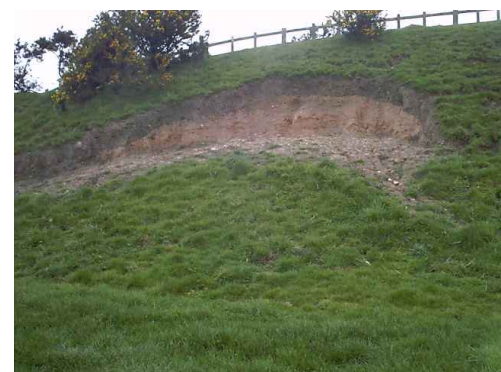
Comment: The slip is greater than half the height of the embankment and is considered to be a major defect. It has therefore been assigned an Initial Feature Grade 1A. It is considered unlikely to affect the carriageway within 5 years therefore the location index remains C.

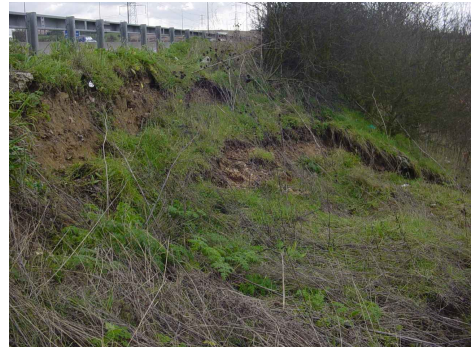
Comment: This slip is major, hence the Class 1A rating. Other slips and minor features are present on the embankment. The verge at the back of the safety fence has been reduced and the barrier may not work as designed. This is a safety-critical defect and the relevant asset manager should be notified ASAP.

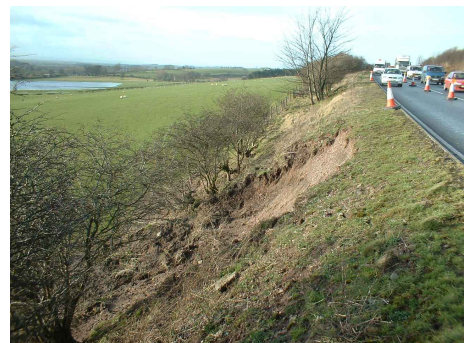
Comment: The current location index of this slip is recorded as C because it doesn't currently affect the carriageway and there is no safety fence.

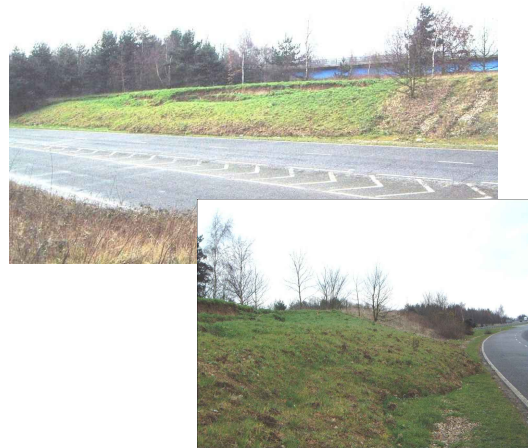
Comment: The slip has not encroached onto the carriageway, therefore the current location index is C. This slip should be flagged for frequent inspections in case the toe moves towards the running lane.

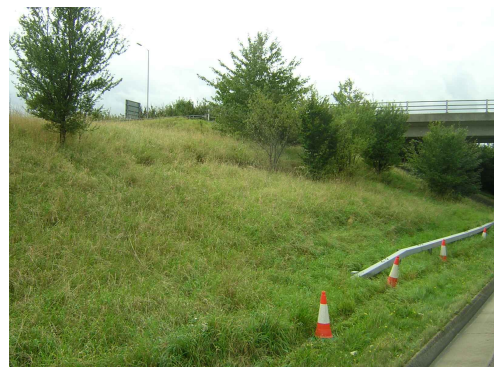
Comment: The slip is localised and displacement is small. The engineer has judged that the slip is not affecting the safety barrier, but the relevant asset manager should be informed. The slip is likely to deteriorate to a major slip within 5 years and the location index has been raised to B. because it is considered likely to affect the safety barrier.

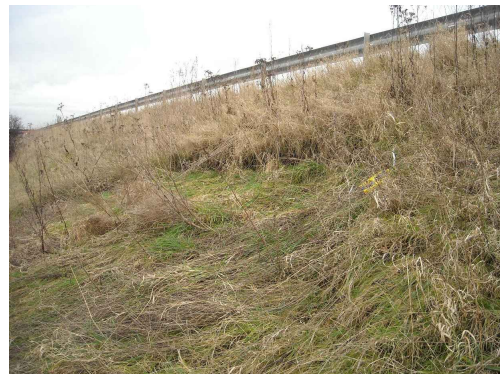
Comment: This slip is typical of many localised shallow slips on the network. This example is currently not directly affecting the safety barrier, however the 5 year assessment considers that it is likely that it will.

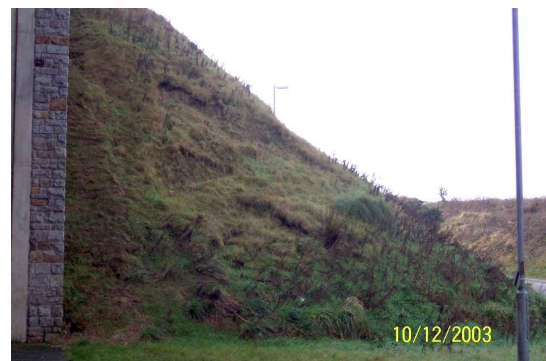
Comment: This localised slip is typical of those found adjacent to structures. The cause is an over-steep slope created to tie in the approach embankment to the structure. Although the slip is restricted to the earthwork, because of the proximity to the structure, the structures asset manager should be informed.

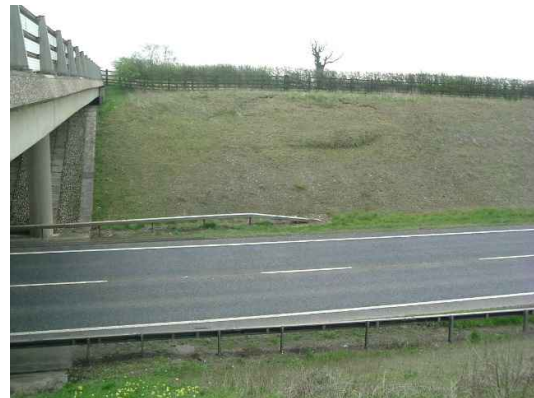
Comment: The slip is localised and quite small, however in the opinion of the engineer, within 5 years it is likely that the slip will increase in size to a major soil slip and encroach onto the running lane and/or affect the structure/safety barrier. The 5 year assessment increases the Feature Grade. It would also be prudent to monitor the slope, taking quantitative readings of displacement and size.

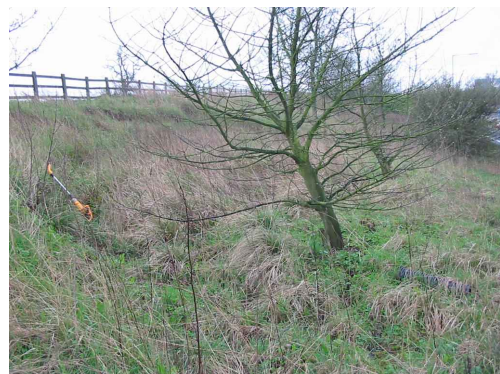
Soil Slip - Dislocated Trees

Comment: The defect is the major soil slip, which has a clearly visible, large back scar. The dislocated trees are an indicator of soil movement. The shape of the trees and the overgrown nature of the back scar indicates that there was probably a single episode of movement, which has stabilised for the time being. The defect should be monitored.

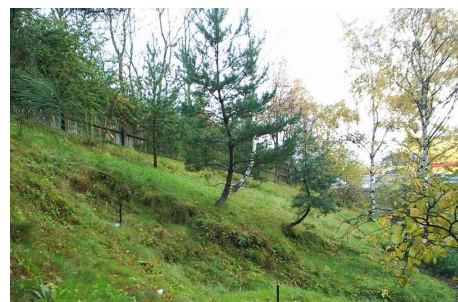
Comment: The defect is the shallow soil movement indicated by the dislocated trees. The shape of the trees indicates that there are constant minor movements. The engineer has decided that the size of the defect is not likely to increase in 5 years and the location index will remain the same.

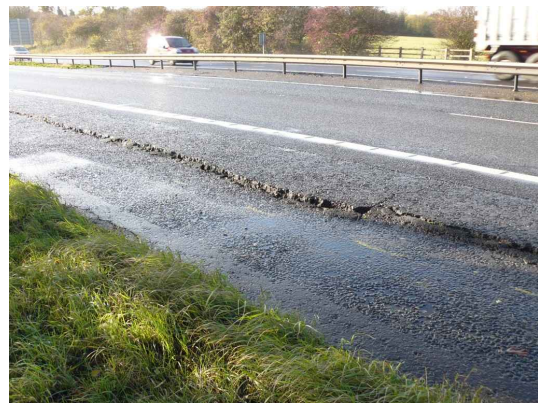
Soil Slip - Pavement Cracking

Comment: The cracking in the hard shoulder is very likely to be geotechnically related as opposed to a road pavement defect because of the significant vertical movement. Displacement is pronounced and requires immediate investigation.

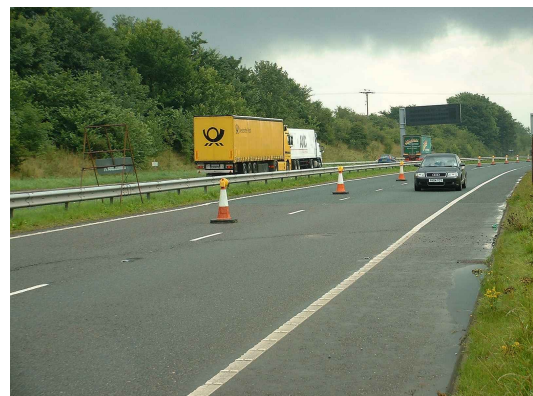
Comment: The immediate cause of the cracking may not be clear, it could be non-geotechnical, i.e. a poorly backfilled trench, or backfill behind an abutment. The arcuate nature of the crack and vertical movement suggest that it may be related to soil movement so the engineer has classified it as a major geotechnical defect. Further inspection/investigation will be required to establish the cause of the cracking.

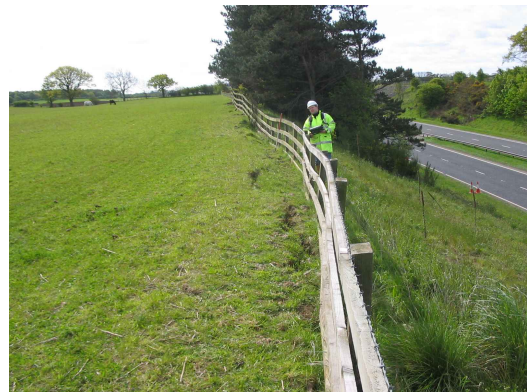
Soil Slip - Combination of Characteristics

Comment: The combination of the significant movement of the fence and the large size of the tension crack suggest that a major defect is likely, hence the 1A classification. In the opinion of the engineer the defect is likely to affect the carriageway in 5 years. The defects should be monitored quantitatively.

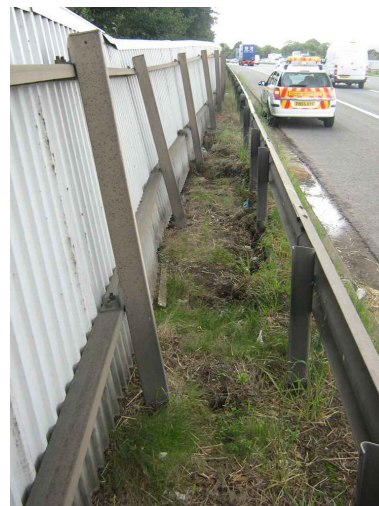
Comment: The combination of significant movement of the boundary fence and tension crack justifies the 1A classification of a major defect. The defect is likely to be safety-critical because it has compromised the performance of the safety barrier therefore the Location Index is A.. The relevant asset manager should be notified.

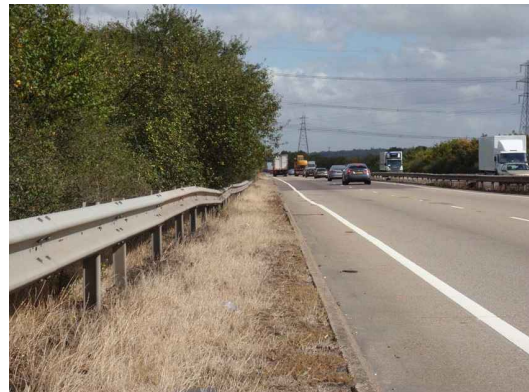
Soil Slip - Combination of Characteristics

Comment: The photograph shows deformation of the safety barrier, but it also shows deformation of the solid white line, indicating that the defect is under the running lane, hence the "A" location Index. Because there is distortion to the safety barrier, the defect should be treated as safety-critical and the relevant asset manager informed.

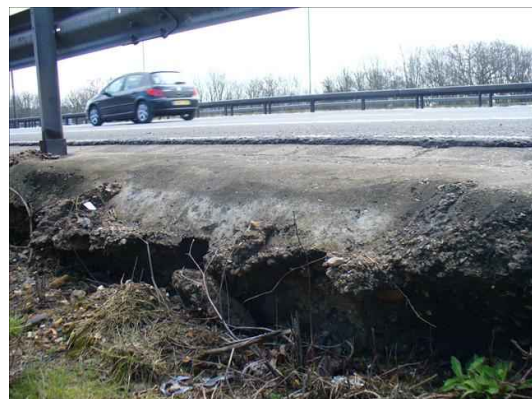
Subsidence

Comment: The defect is safety-critical because the performance of the safety fence and/or carriageway is very likely to have been compromised. The relevant asset manager should be notified.

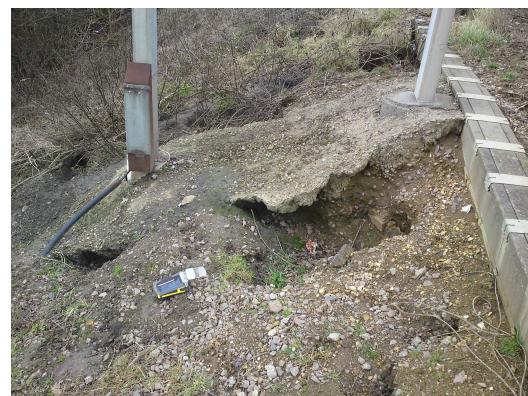
Comment: There is minor subsidence to a poorly cast sign base. There is also a comms/service cable at the top of the slope. The defect should be inspected frequently and the relevant asset manager informed of the condition.

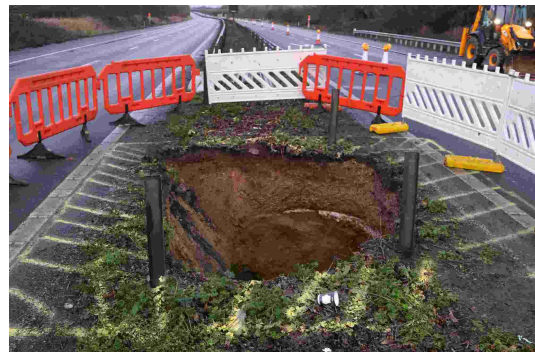
Subsidence

Comment: The defect is safety-critical because the performance of the safety fence and/or carriageway has been compromised.

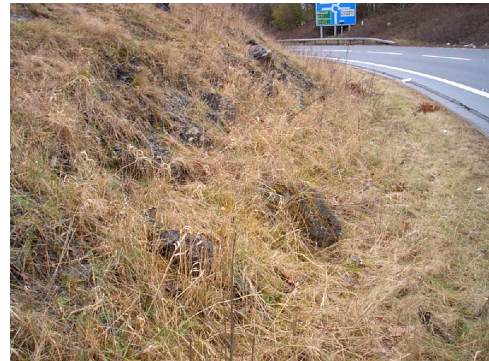
Ravelling

Comment: The ravelling is minor and set back from the carriageway edge. The engineer has decided that it is unlikely to deteriorate within 5 years.

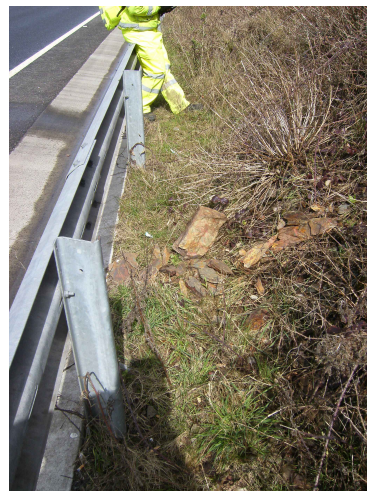
Comment: The fallen blocks of rock are not encroaching onto the carriageway at the time of inspection. The engineer considers that within 5 years the accumulation of blocks will eventually impinge onto the carriageway. This defect should be flagged for frequent monitoring.

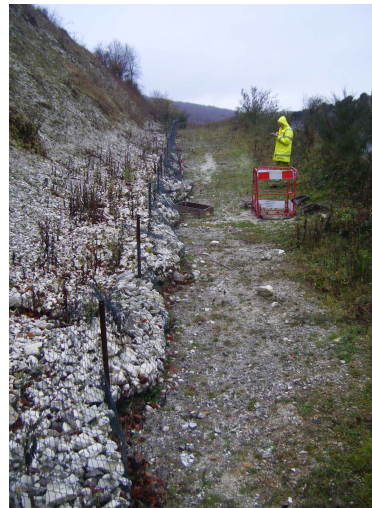
Ravelling - Debris Fence

Comment: The defect (ravelling) has been given a class 1D because of the size of the fallen blocks. The debris fence is deformed but working well. It should be noted that maintenance will be required to clear the debris in the fence.

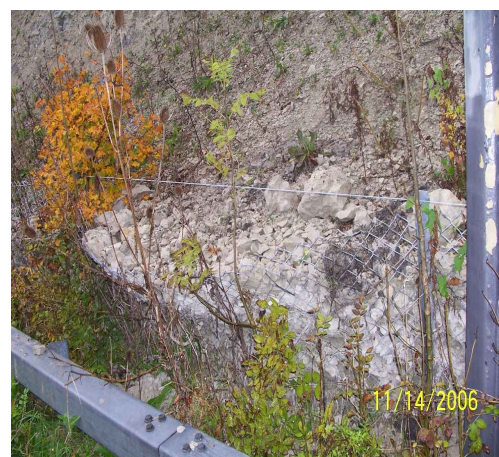
Comment: The defect is considered to be minor. The debris fence should be inspected and programmed for maintenance/replacement as soon as possible.

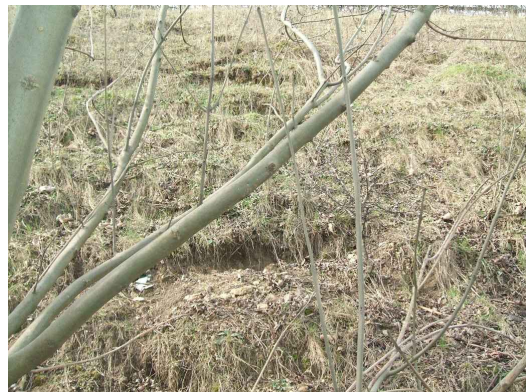
Comment: Terracing is a common feature of over-steep slopes, especially on weak rock formations and soil slopes. The feature has been classified as “at-risk” rather than a defect, because it is a common slope evolution process.

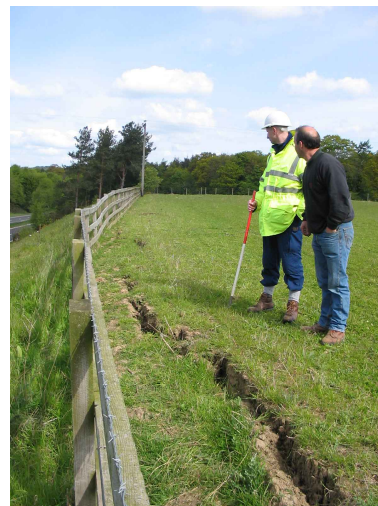
Tension Crack

General Description: Cutting slope showing tension crack at crest.

Comment: The tension crack is at the top of a cutting. The defect considered minor at the time of the inspection due to its limited extent, however in the opinion of the engineer the tension crack is likely to develop into a major defect within 5 years that will affect the carriageway. The defect should be monitored taking quantitative readings.

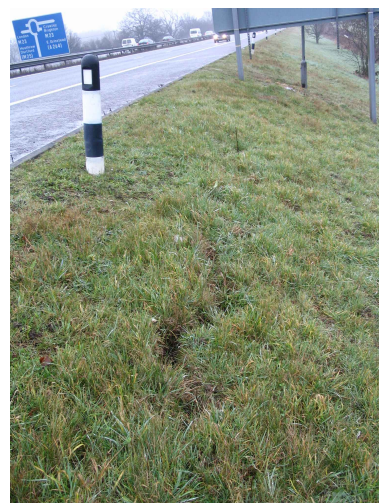
General Description: Minor tension crack on embankment slope.

Comment: Because tension cracks can be an early indicator of slips, the crack width should be monitored, taking quantitative readings.

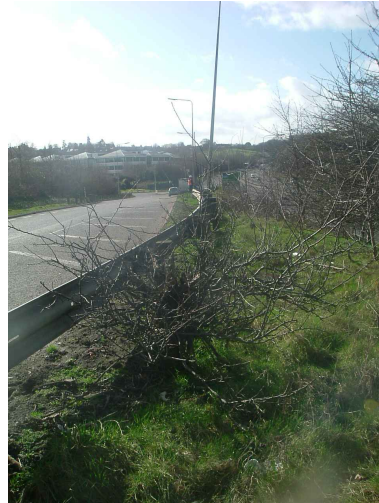
General Description: The inspector has noticed that a lighting column has rotated. The cause is unknown.

Comment: The exact cause of the movement of the lighting column is uncertain (poor foundations, vehicle impact, or ground movement), so the classification of the observation has been assigned 2 (“at-risk”). The relevant asset manager should be informed and a detailed inspection carried out.

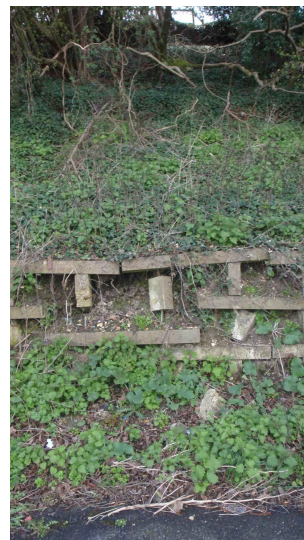
Comment: The crib wall structure has become distorted and is not working properly. The structures asset manager should be informed.

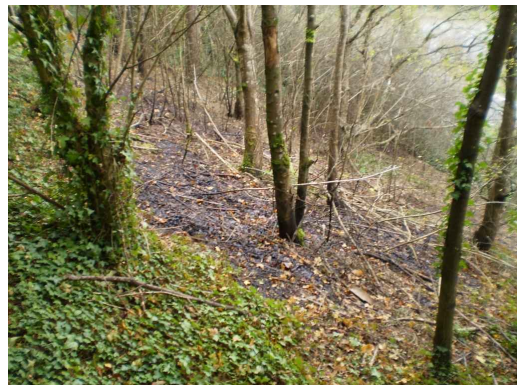
Leachate

General Description: Diesel leaking onto a cutting slope from an adjacent land owner.

Comment: Whilst this defect isn't "geotechnical" it is unlikely to be recorded elsewhere, therefore it is appropriate to record it and classify it on the geotechnical asset management system. The defect should be brought to the attention of the relevant technical expert ASAP.

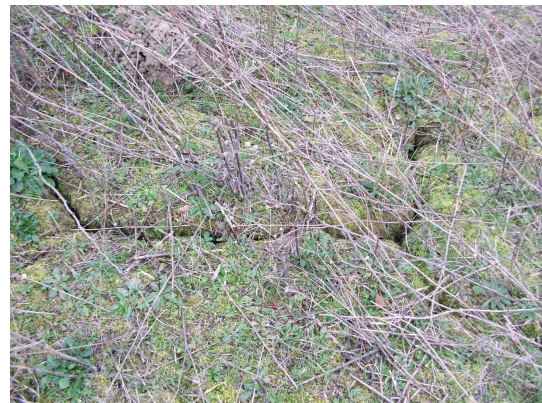
Desiccation features

General Description: Small cracks in ground surface.

Comment: Desiccation cracks are often found in soil during prolonged periods of dry weather. They rarely pose a problem on their own. It may be an indication that the soil is susceptible to shrinkage and swelling, so adjacent structures should be investigated.

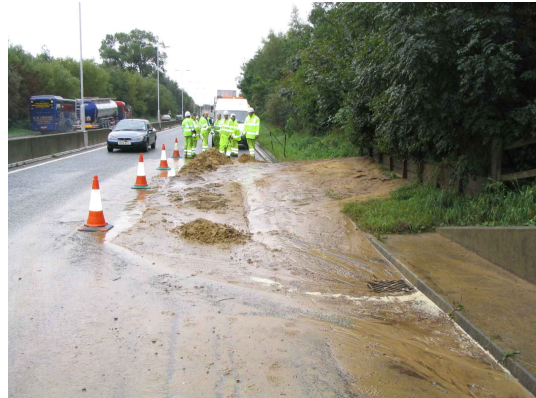
Toe Debris

Comment: The debris has washed out of the slope following a heavy rain event. It has blocked a part of the carriageway. The risk rating could be carried out again once the incident has been cleared up. The 5 year risk rating assumes that the flood event will occur again in 5 years.

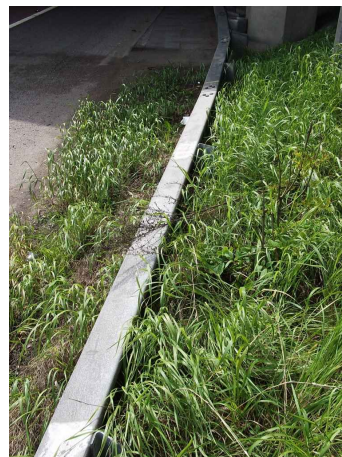
General Description: Debris from a localised cutting slope failure encroaching under a safety barrier.

Comment: Soil has washed out/slipped under the safety barrier. The vegetation indicates that it is an old feature that may have stabilised. It is a safety-critical defect because the safety barrier is compromised so the relevant asset manager should be notified. A geotechnical engineer should be involved in the design of any works to repair the barrier as it will involve removal of material from the toe of the slip.

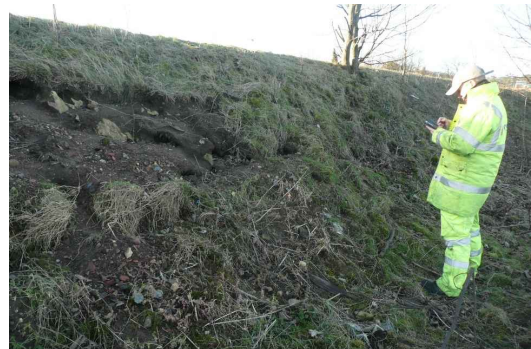
Animal Burrows

Comment: The rabbit burrows have fresh soil around the entrances, indicating that the warren is active, but there is no sign of a defect to the carriageway or slope. The engineer considers it likely that within 5 years the rabbit burrows are likely to cause a minor defect. The site should be quantitatively monitored to determine whether the warren is getting larger.

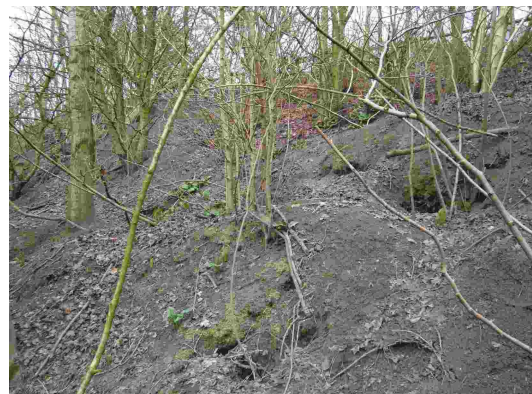
Comment: Badger setts can be distinguished from rabbit warrens by significant amounts of spoil around the entrances. The advice of an environmental expert indicates that the sett is unlikely to increase in size over 5 years. The sett should be quantitatively monitored and the environmental expert informed of any changes.

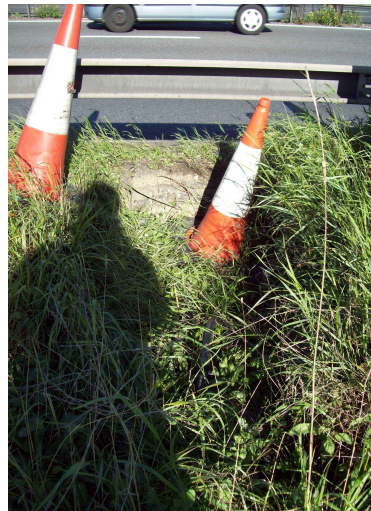
Poorly Backfilled Trench

Comment: The trench is a hazard for road users who may need to seek refuge behind the safety barrier. The relevant asset manager should be informed.

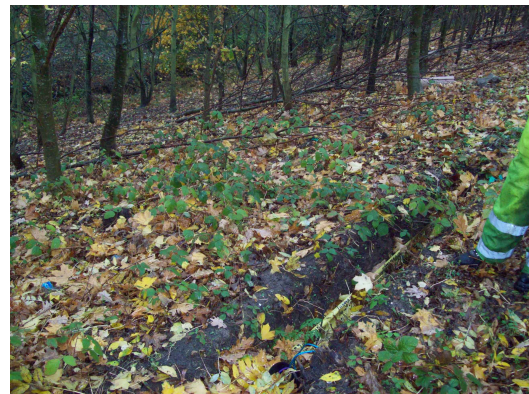
Comment: The engineer has decided that the defect is not likely to be a major defect within 5 years. The relevant comms asset manager should be informed.

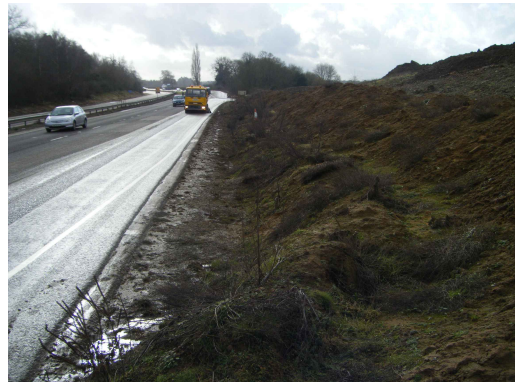
Landfilling

Comment: At this site the landfill operations weren't being controlled properly. There is no current defect, but the engineer has assessed the site to be "at-risk" (2) The relevant property/planning manager should be notified immediately.

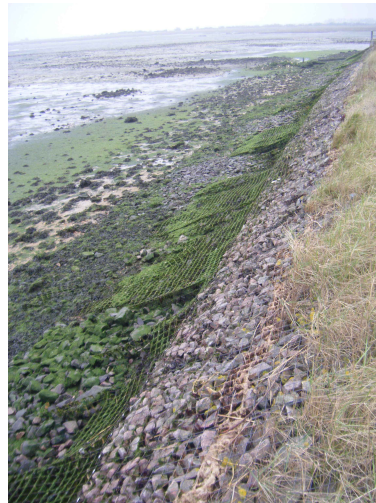
Reinforcement

General Description: Revetment showing broken gabion mats.

Comment: The gabion mats forming the base of the revetment have broken. The revetment is quite a distance from the carriageway. Monitoring is recommended, especially after storm events.

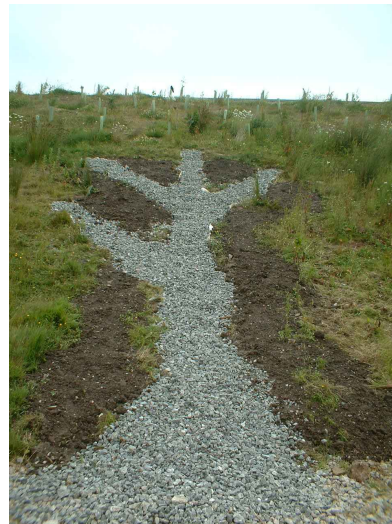
Reinforcement

Comment: The soil slope has had preventative works carried out. Counterfort slope drains have been installed.

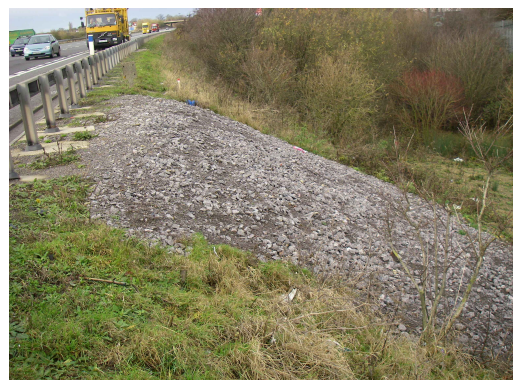
General Description: Embankment granular repair

Comment: A soil embankment has been repaired using excavation and granular replacement.

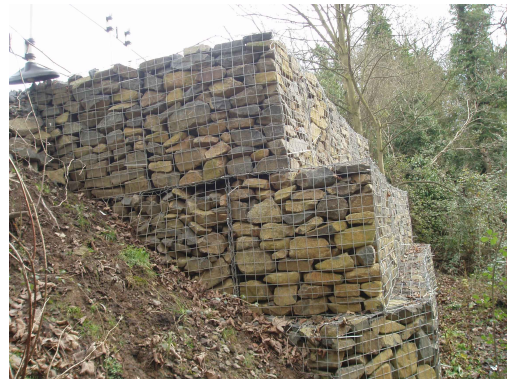
Reinforcement

General Description: Embankment slope repair using gabion baskets.

Comment: A defect has been repaired using gabion baskets.

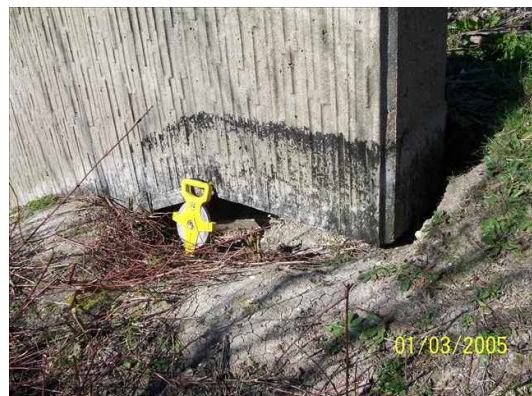
Other Defects

Comment: The photos appears to show that soil has been washed under a structure. The Structures asset manager should be notified. The cause of the washout would need to be traced.

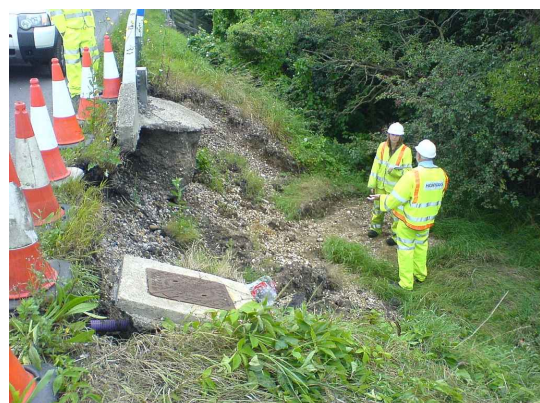
General Description: Localised washout from a drainage defect on an embankment.

Comment: The washout has been caused by a drainage defect. The running lane is very close to the unsupported slope and the safety barrier has been undermined so the location index has been set to A. The defect is safety-critical and the relevant asset managers should be informed.

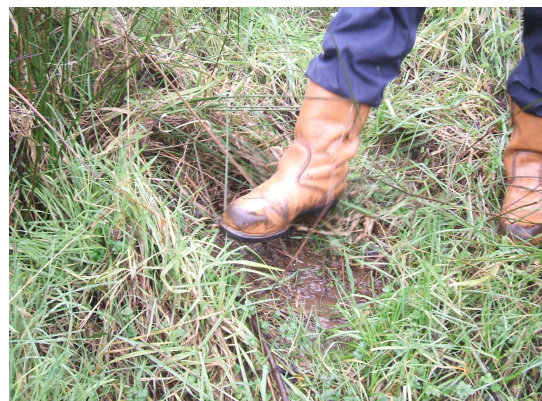
Comment: The photograph shows seepage together with hydrophilic vegetation, suggesting that the seepage is constant and not due to a single rainfall event.

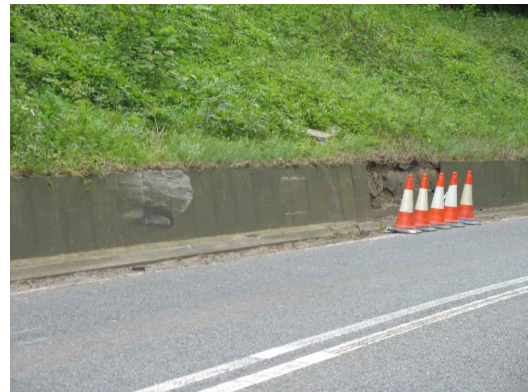
Other Defects

General Description: Paving slab revetment broken by road traffic accident.

Comment: It appears that the paving slab revetment has been broken by an RTA and observations indicate that the site may be subject to frequent incidents. The warning measures (traffic cones) are encroaching onto the running lane so a location index of A has been assigned. The structures asset manager should probably be informed, even though it is technically not a structure.

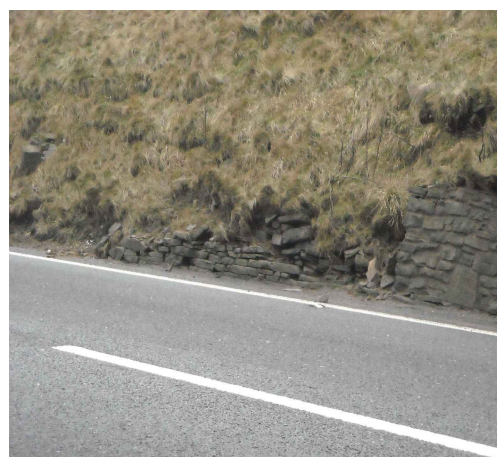
General Description: Low height stone retaining wall/revetment is damaged.

Comment: The wall/revetment has deteriorated and fallen blocks may present a hazard. The relevant asset manager should be informed and the site monitored.

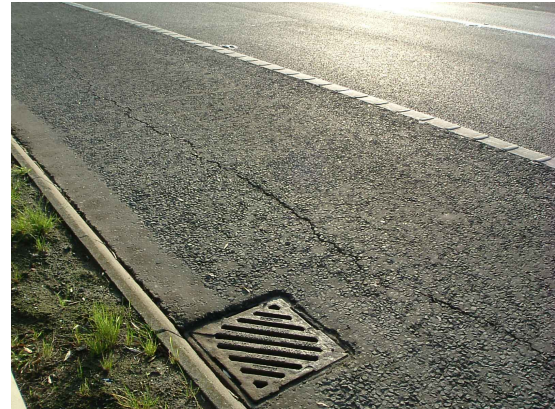
Non-Geotechnical Pavement Cracking

General Description: Minor cracking of the carriageway.

Comment: The cracking is minor, and almost certainly due to poor pavement edge construction and/or specification. It is not a geotechnical defect, but should be reported to the relevant asset manager.

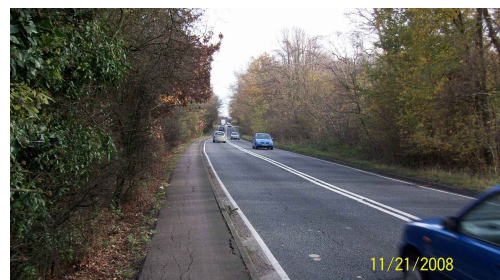
General Description: Longitudinal cracking in the footway and in the carriageway.

Comment: The cracking is due to shrinkage of the soil caused by moisture demand from the adjacent trees. Because there is no underlying geotechnical feature such as a slip, the responsibility for maintenance of the carriageway and footway rests with the highways team. To record this as a geotechnical feature as a defect would be “double counting”. However it could be recorded and not assigned a class or risk rating. It would be prudent to inform the highways team and provide input into the design of the reconstruction.

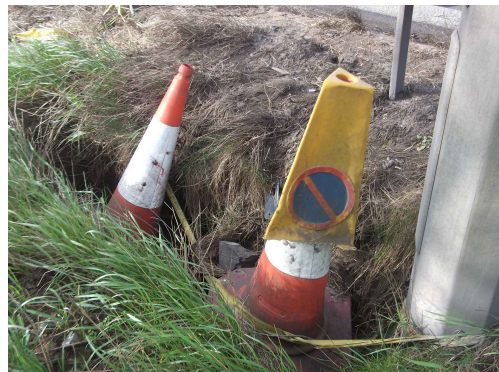
Non Backfilled Excavation

Comment: The excavation is behind a safety barrier and adjacent to a lamp post on an at-grade section. It is a minor, non-geotechnical defect, but it is safety-critical, especially to road users who may need to seek refuge behind the safety barrier. It must be reported to the relevant asset manager. If the excavation was at the crest of an embankment and could cause instability by collect of water and discharge into the slope it should be treated as a geotechnical defect.

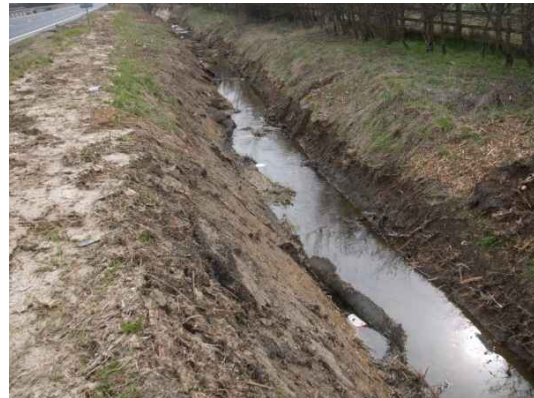
Unlined Ditch

Damage/defects to the side walls and the partial blockage should be reported to the Asset Manager.

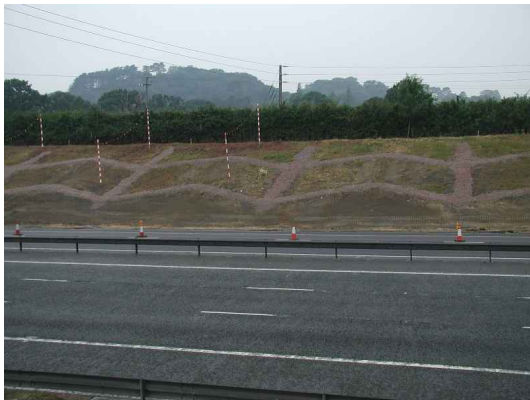
Herring bone drainage

These drains are part of the design of the slope. They should be recorded but feature grade assigned because they are not part of a repair.

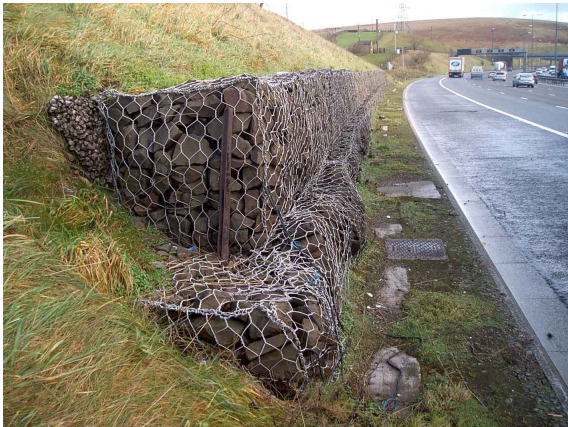
Gabions

Note that these were installed as part of the original slope design and therefore do not need to have a feature grade assessment.

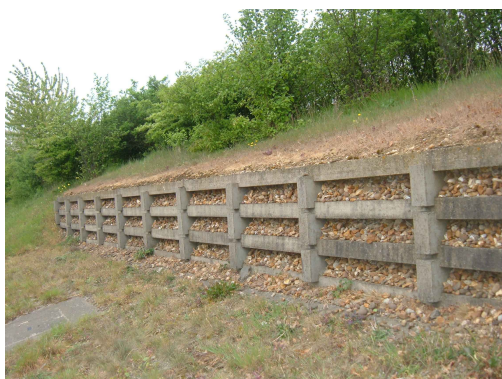
Crib Wall

This crib wall was designed as part of widening works. It is not a slope repair and therefore does not need have a feature grade assessment.

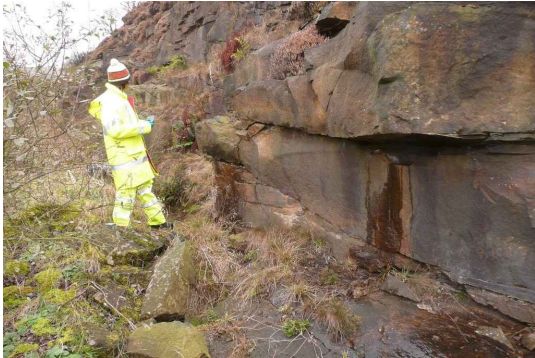
Water Seepage from a rock. 56

This seepage is not a defect, it's a naturally occurring feature. It should be recorded as an observation, and monitored, especially if there are down-slope hazards.
